Post Flood Report: Record Rainfall and Flooding Events During September 2013 in New Mexico, Southeastern Colorado and Far West Texas

**US Army Corps
of Engineers®**
Albuquerque District

November 2014

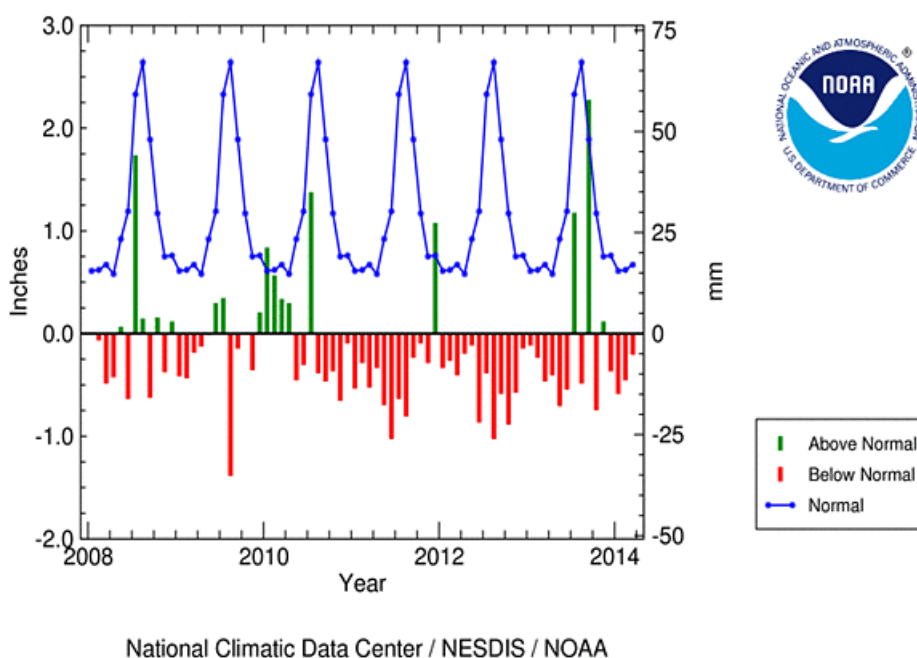
Figure 15 - New Mexico statewide precipitation, normals and departures, January 2008 through March 2014 (NOAA/NWS 2013u).

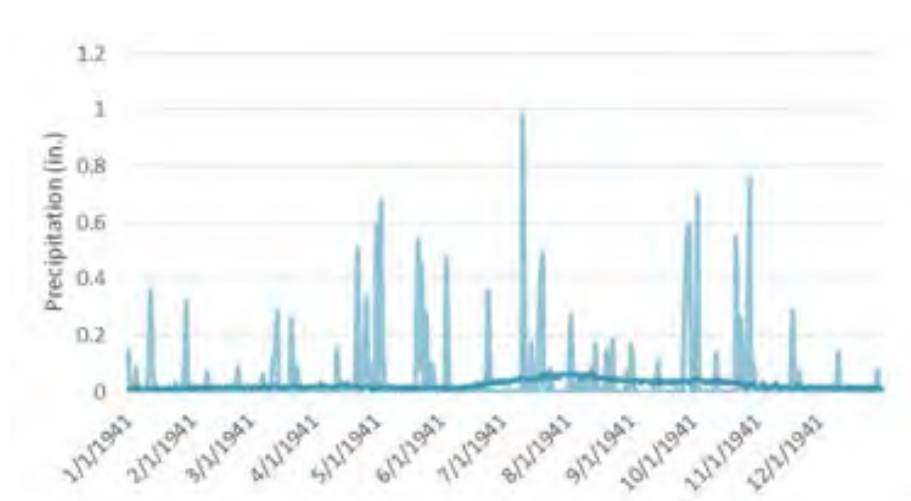
Figure 18 - Precipitation in Albuquerque during 1941 (light blue line) and average precipitation for those dates (darker blue-green line) (NOAA/NWS 2013u).

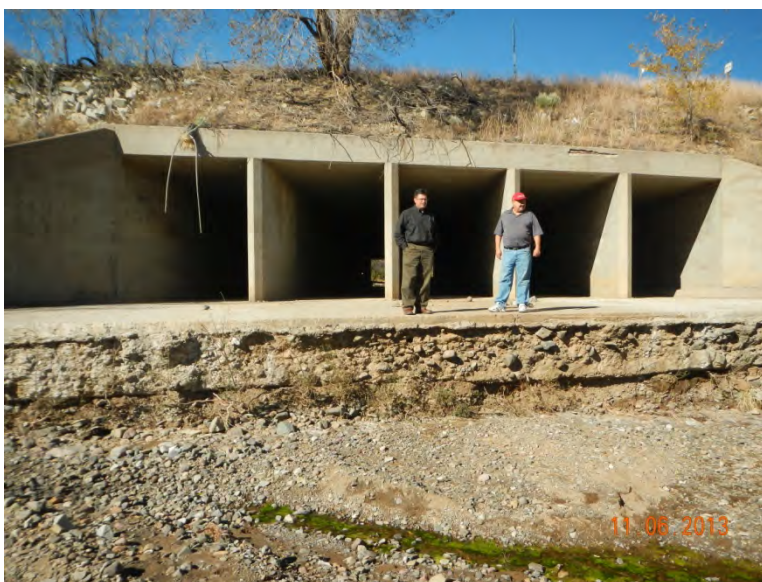
Flooding in Santa Clara Canyon filled and breached detention ponds up canyon, compromising their future flood mitigation effects. The flood waters moved downstream and the stage gage recorded a maximum stage of 9.59 ft. Based on observed high water marks along the Creek and downstream of the Highway 30 box culverts, this series of floods at a minimum equaled the peak flow rates of the 20 July 2013 flood event (for which a separate FEMA Disaster Declaration was issued), with a much larger volume of sustained flood flows.

Figure 20 - Damage at the Village of Santa Clara, NM (Grant County), included 5 feet of downcutting immediately downstream of this box culvert.

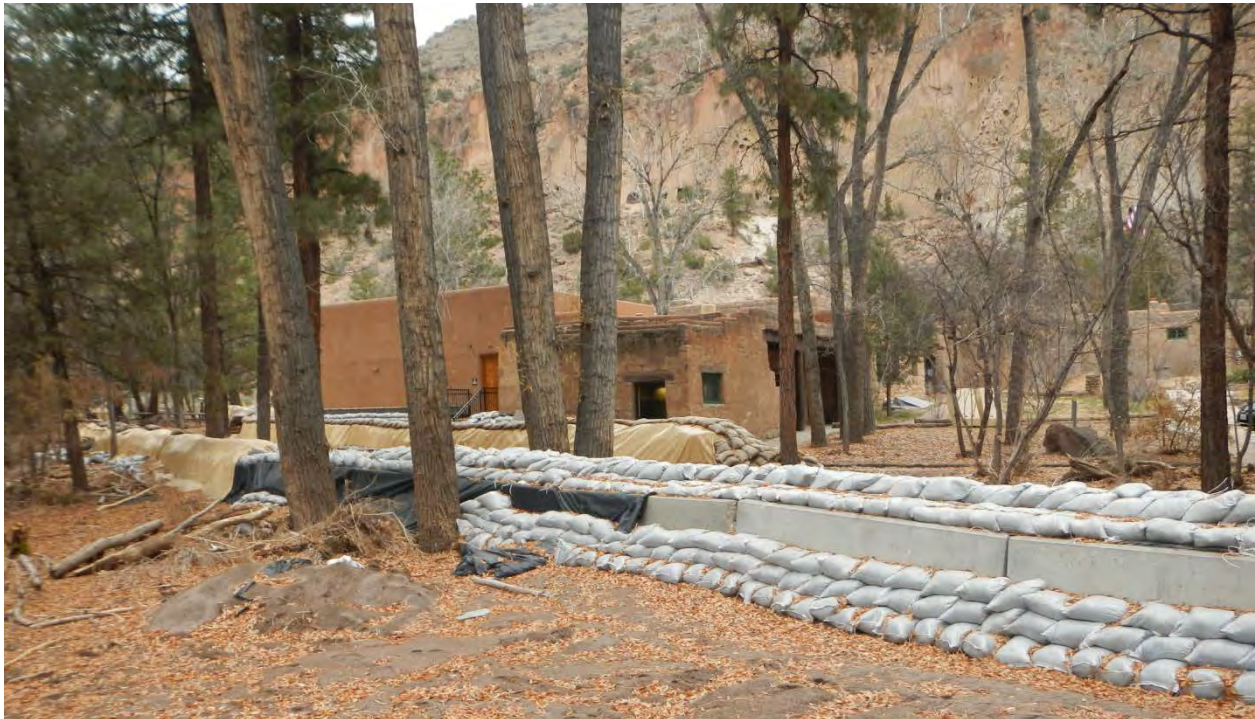
Figure 21 - Sandbags and Jersey barriers used to prevent flood damage to historic buildings at Bandelier National Monument.

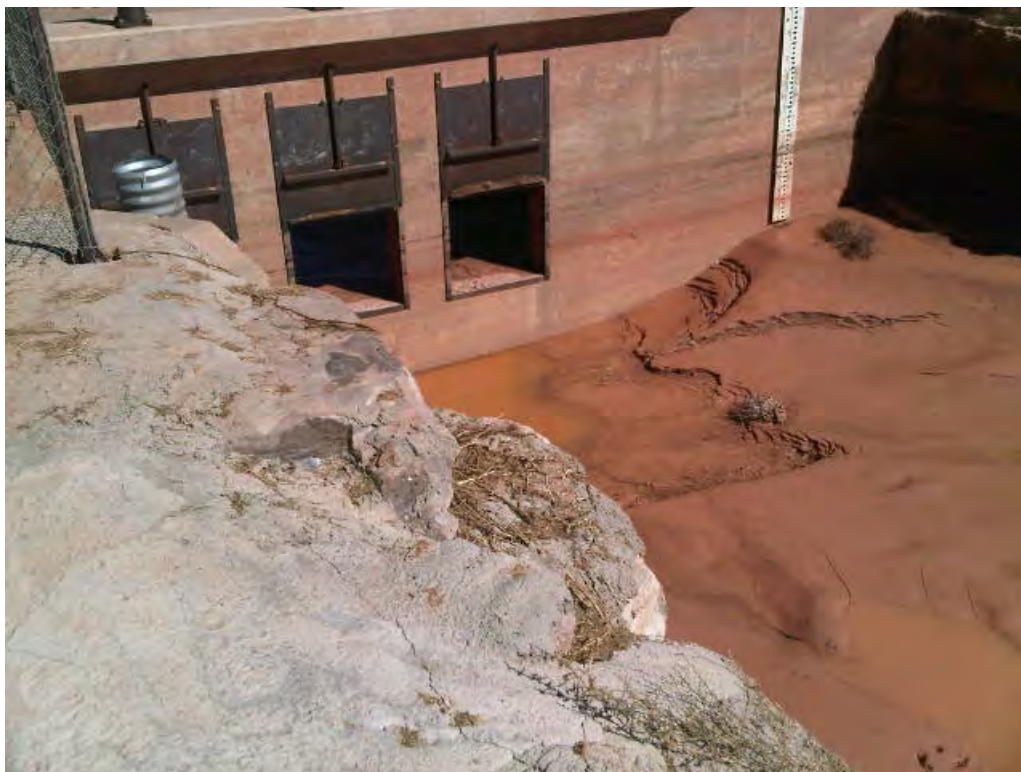
Figure 32 - Flood damage to a diversion structure in Many Farms, Navajo Nation (courtesy of Rose Whitehair).

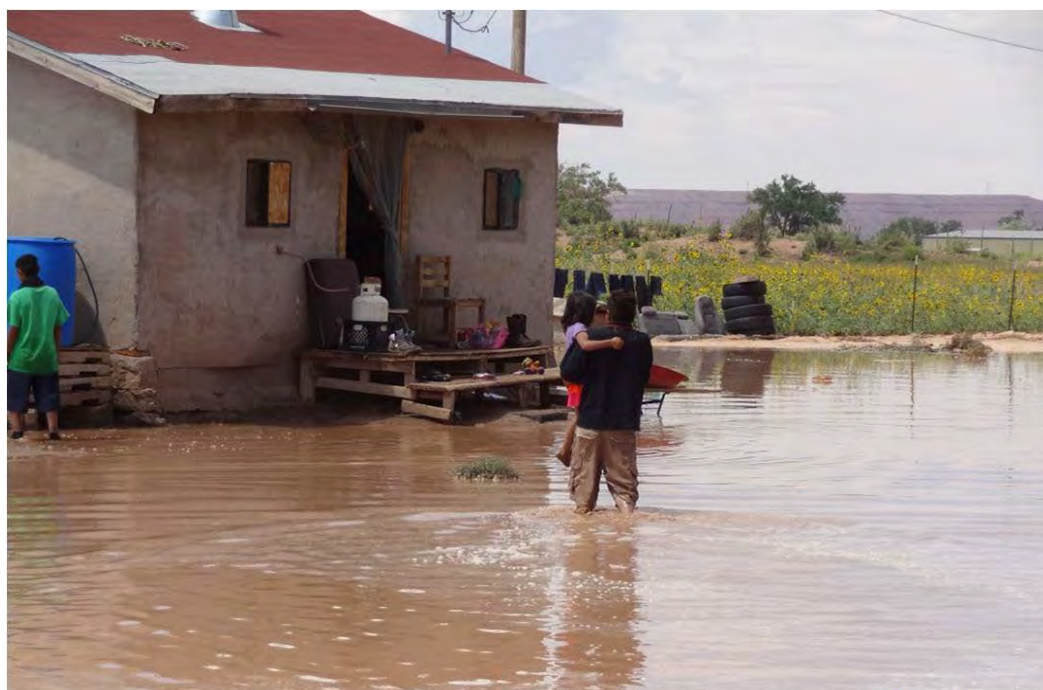
Figure 33 - Flood damage to a home in Chinle, Navajo Nation, Arizona (courtesy of Rose Whitehair).

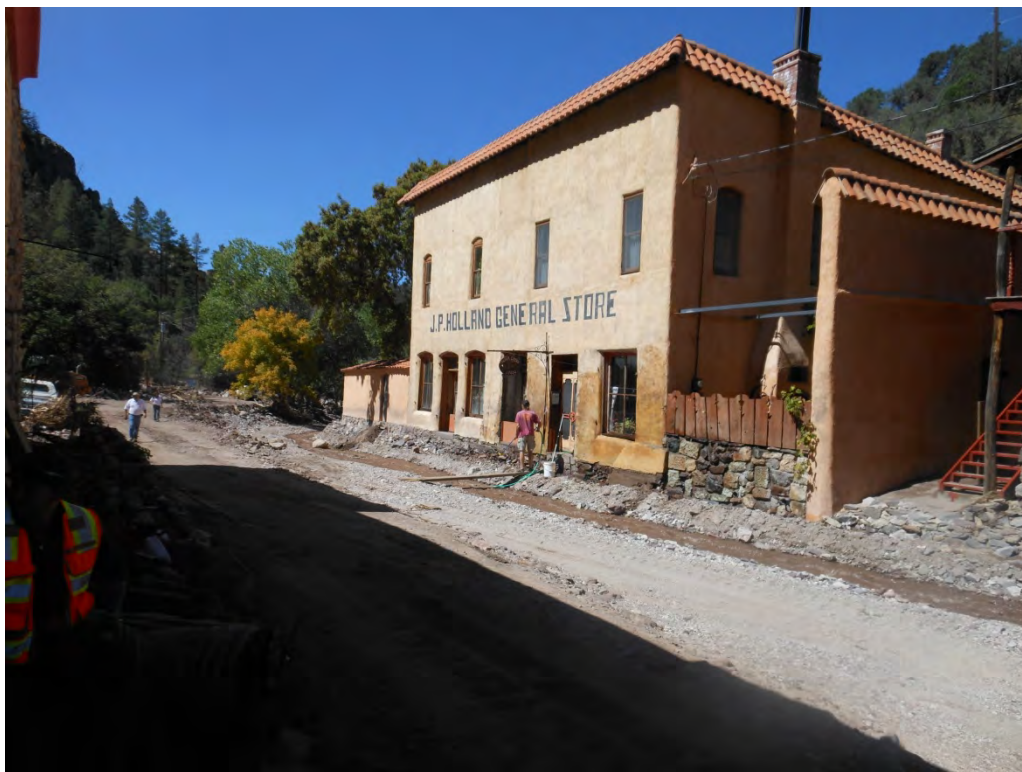
Figure 35 - High water mark on the general store, Mogollon, NM.

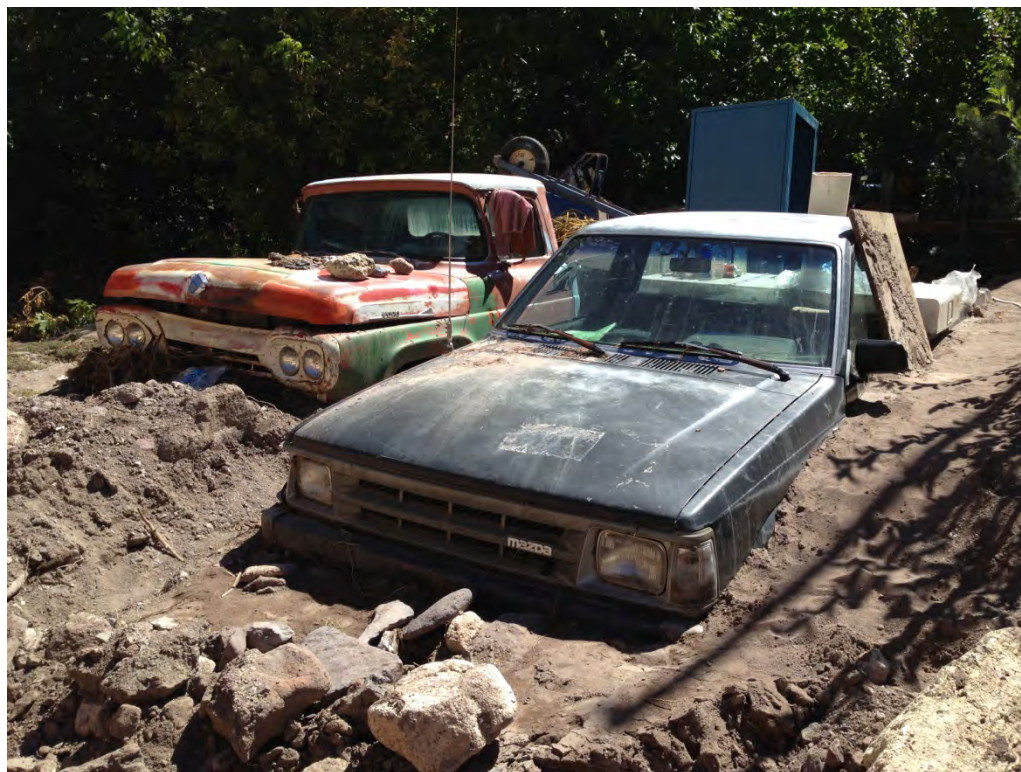
Figure 36 - Cars buried in sediment following a September 2013 flood in Mogollon, NM.

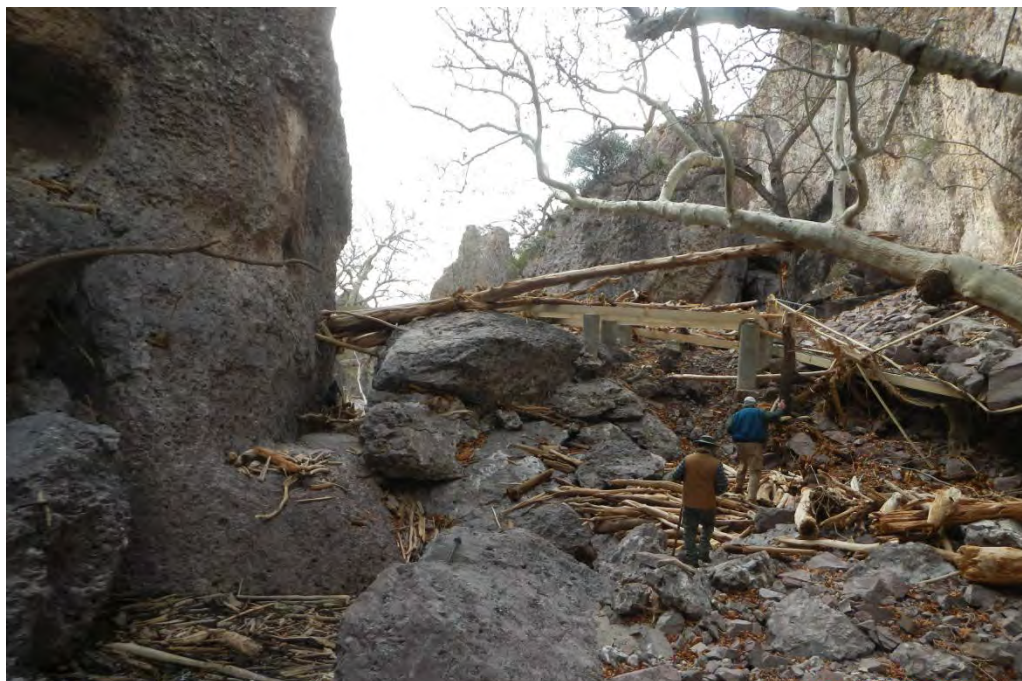
Figure 37 - Flood damage to the Catwalk, a popular tourist destination near Glenwood, NM.

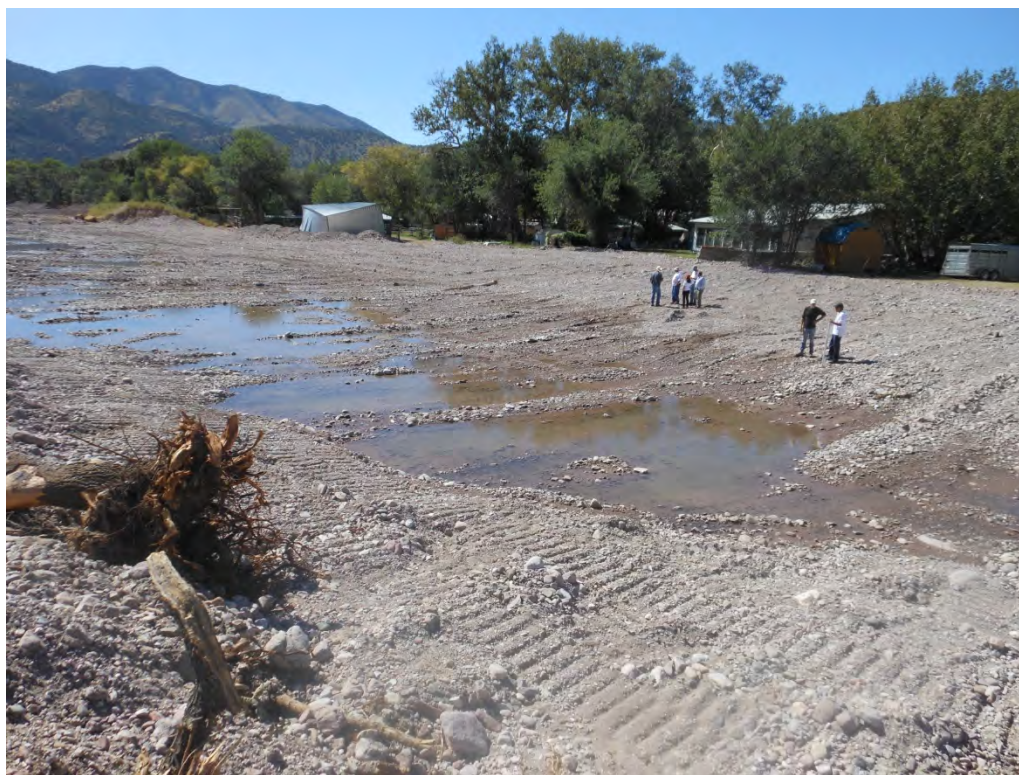
Figure 38 – Channel work along Whitewater Creek, near Glenwood, NM, following a September 2013 flood event.

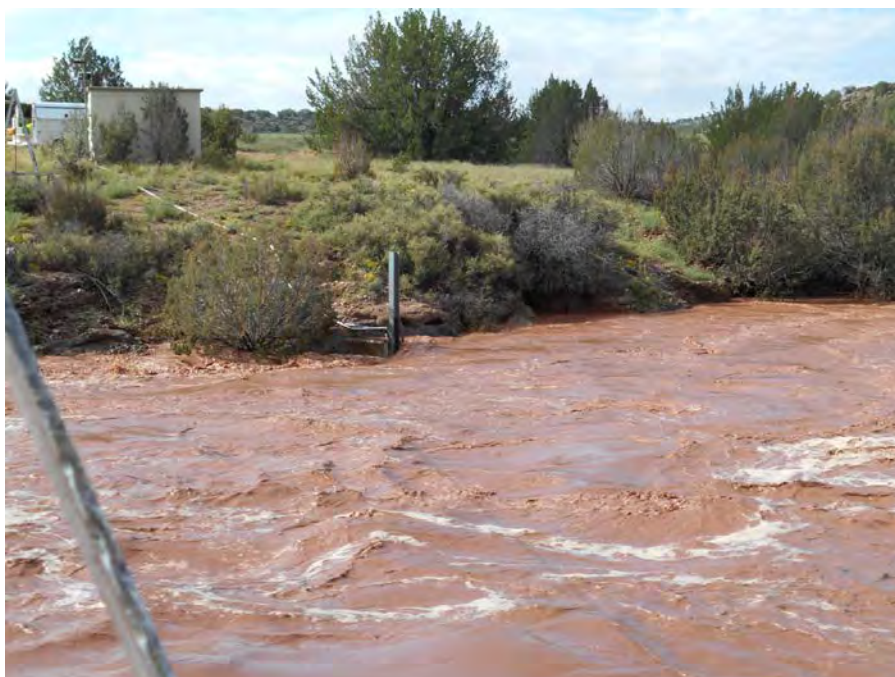
Figure 1: Pecos River below Cañon del Uta (08382600) staff gage, September, 2013. (Photograph by M. Carlson.)

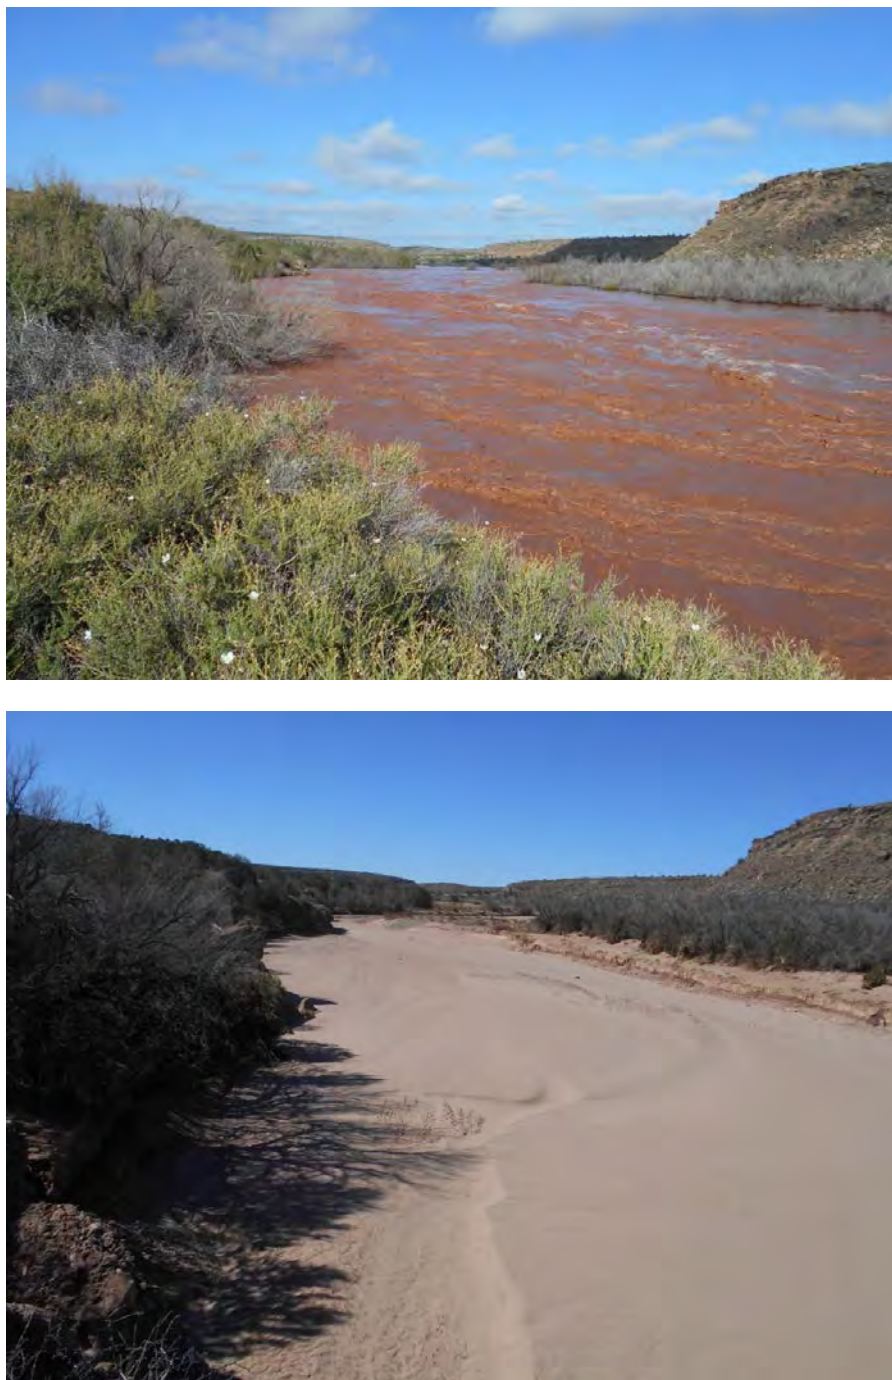
Figure 2: Pecos River upstream from the streamgage at Cañon del Uta. *A*, September 2013. *B*, October, 2013. (Photographs by M. Carlson.)

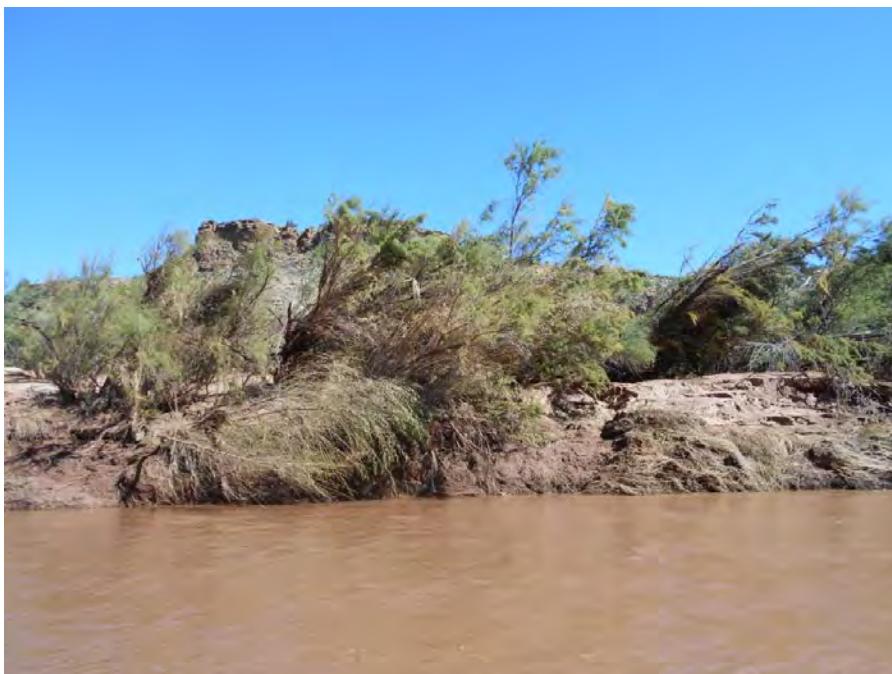
Figure 3: Pecos River above Santa Rosa Lake (08382650) showing affects of overbank flooding on riparian vegetation, September, 2013. (Photograph by M. Carlson.)

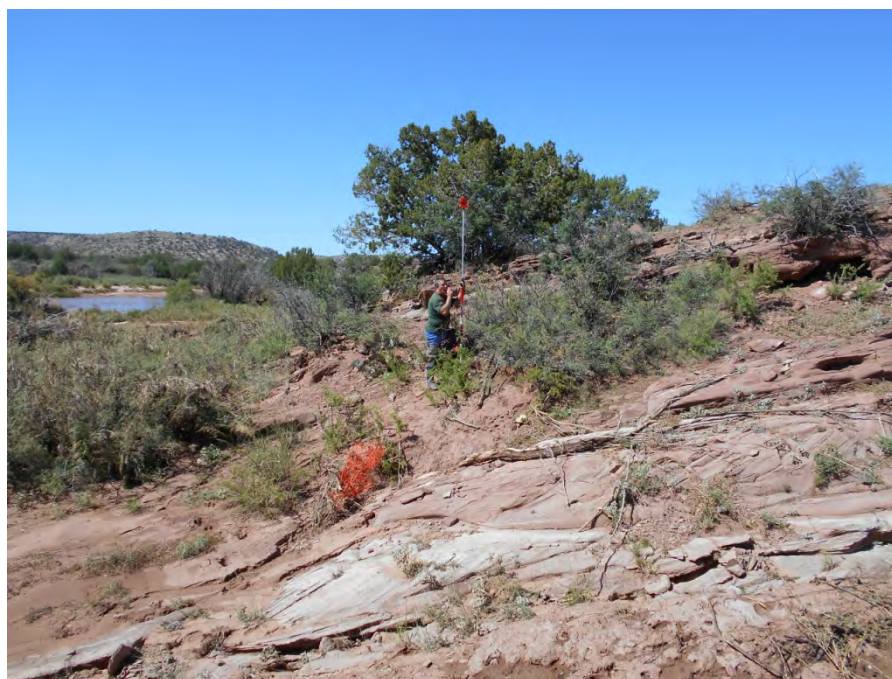
Figure 4: Pecos River near Puerto de Luna (08383500), September, 2013. Survey rod marks location of high-water mark. Pecos River is to the left in the photograph. (Photograph by M. Carlson.)

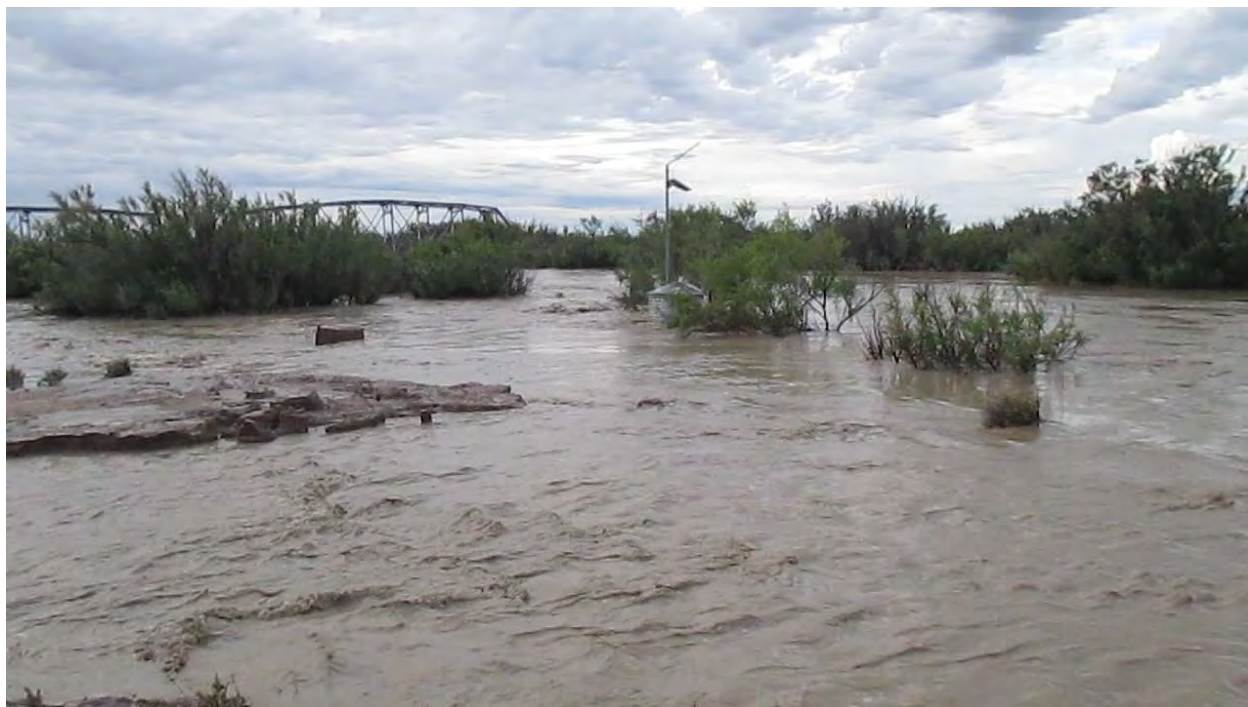
Figure 5. Rio Puerco near Bernardo (08353000), September 16, 2013. Flood peak occurred near midnight. Submerged gage house is seen in center of photograph. (Photograph by J. Cederberg).

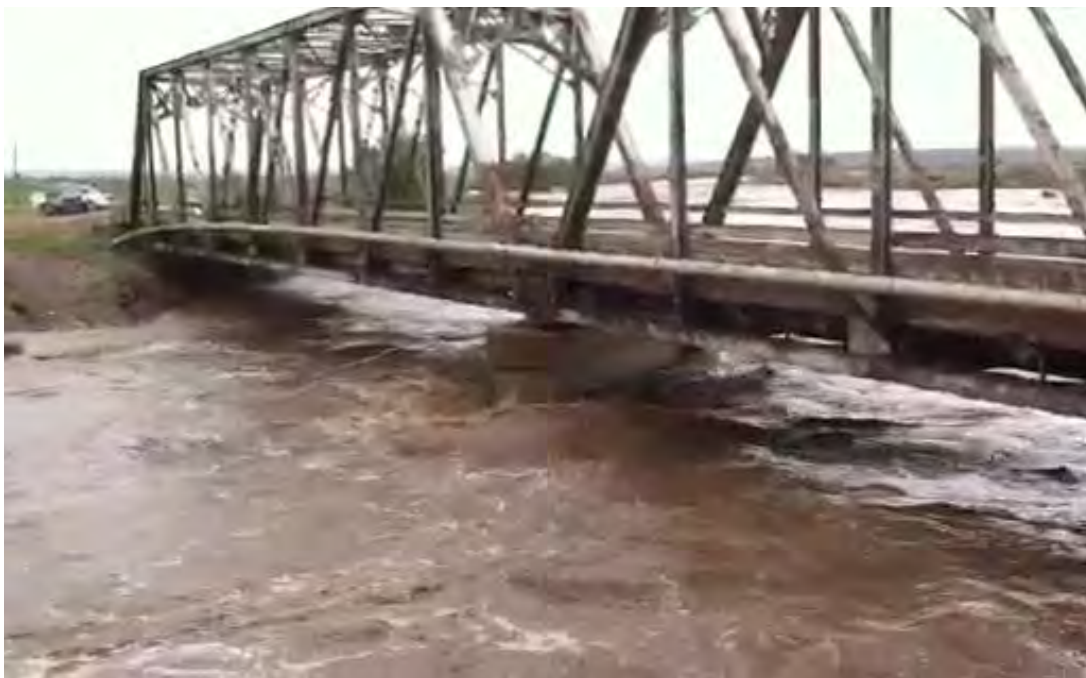
Figure 6: Rio Felix at Old Highway Bridge near Hagerman, NM (08394500), September 12, 2013. (Photograph by A. McGlone.)

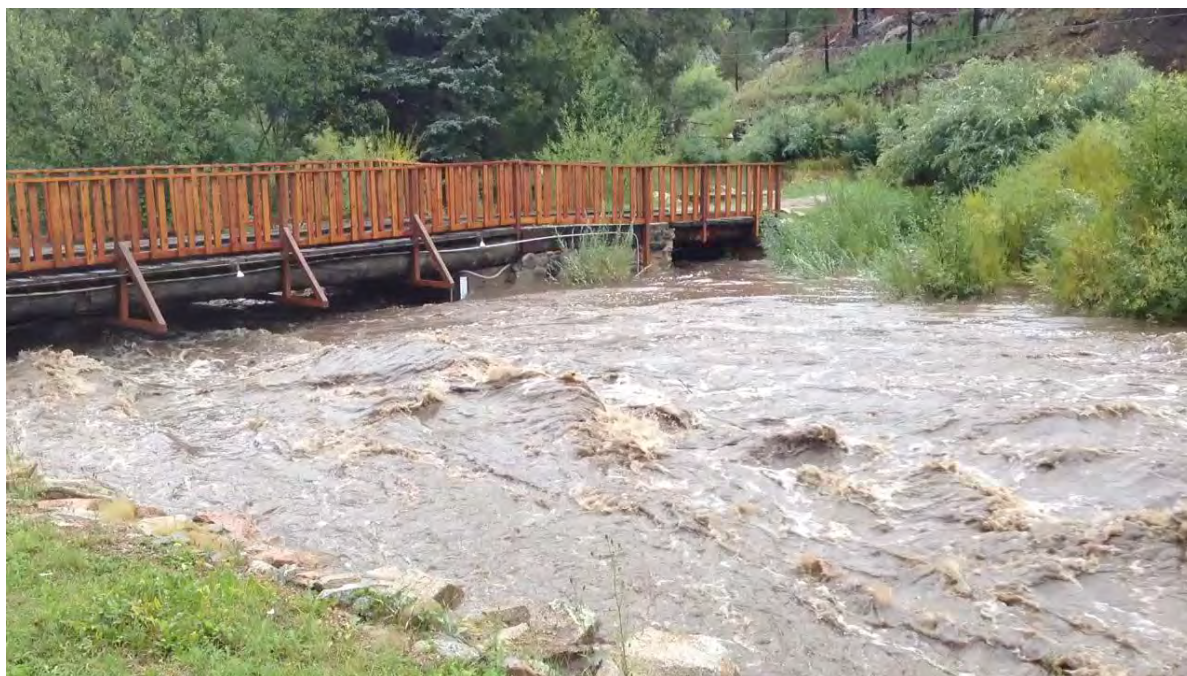
Figure 7. Rio Puerco near Pecos (08378500), September 13, 2013. (Photograph by J. Cederberg).
